DEVELOPMENT OF THERMAL BARRIERS FOR SOLID ROCKET MOTOR NOZZLE JOINTS

Bruce M. Steinetz and Patrick H. Dunlap, Jr.  
National Aeronautics and Space Administration  
Glenn Research Center  
Cleveland, Ohio

1999 NASA Seal/Secondary Air System Workshop  
October 28-29, 1999

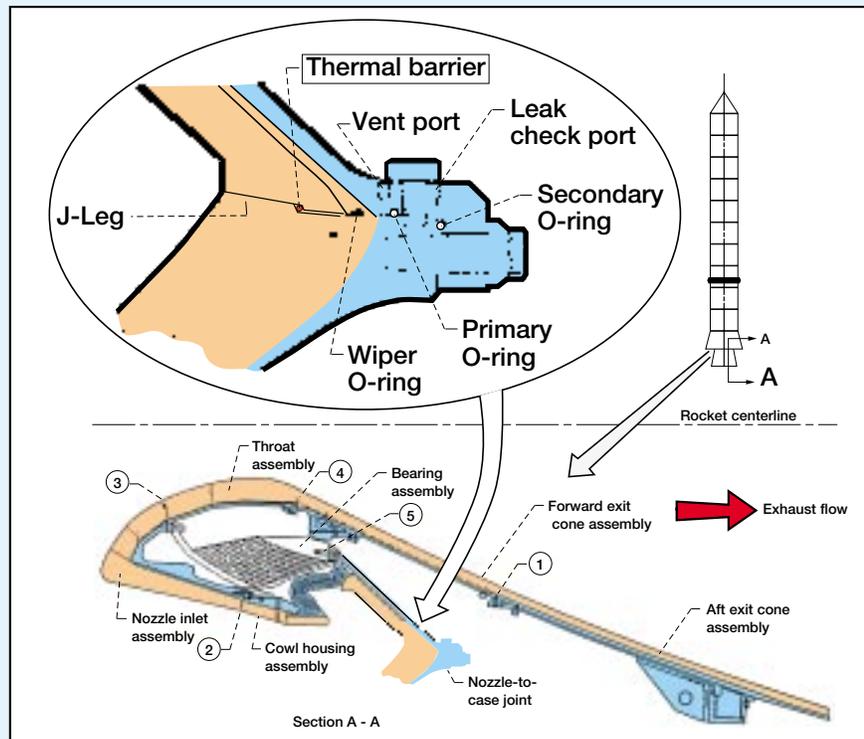
## SRM Nozzle-to-Case Joint: Potential Location for NASA Glenn Thermal Barrier

This chart shows where Thiokol plans to use the thermal barrier in the nozzle-to-case joint of the Shuttle solid rocket motor. The figure at the bottom is an enlarged area of the rocket nozzle showing the nozzle-to-case joint and nozzle joints one through five. Thiokol has recently begun an aggressive plan to qualify the thermal barrier for use in Joint 2 and is considering using it in other nozzle joints. The figure at the top is an enlarged view of the nozzle-to-case joint. The primary, secondary, and wiper O-rings are shown along with the phenolic insulation (in orange) and the surrounding metal hardware (in blue). The J-leg in the insulation is also indicated. The thermal barrier is highlighted in its position upstream of the O-rings where it would help block hot combustion gases from reaching the O-rings.

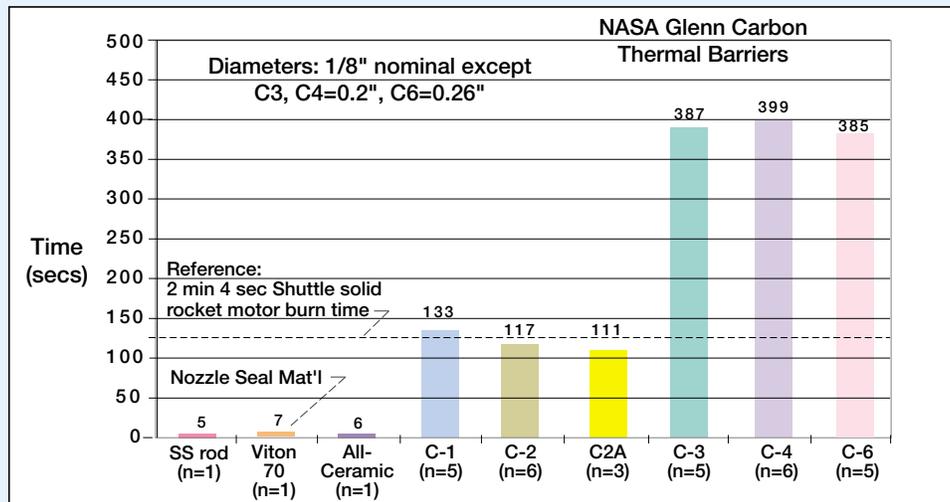
## Oxyacetylene Torch Results

- NASA Glenn braided carbon thermal barrier (C-6) resists flame for over 6 minutes: Expected joint cavity fill time  $\leq 10$  sec
- Anticipated carbon barrier mass-loss mechanism: Carbon fiber oxidation  
- Carbon sublimation temperature (6900°F) > Rocket hot gas temperature (5500°F)
- Test believed to be conservative for carbon thermal barriers as rocket exhaust chemistry is less oxidative than torch burn test

When Thiokol first approached NASA Glenn about this problem, we devised a simple test to screen different thermal barrier materials and designs. Candidate materials were subjected to a test in which specimens were placed into the flame of an oxyacetylene torch and the amount of time to completely burn through them was measured. The torch was adjusted until a neutral flame was formed, and the thermal barrier materials were placed in the hottest part of the flame at the tip of the inner cone where temperatures reached 5500°F. This chart shows the results of burn tests performed on candidate thermal barrier materials and designs. It shows the amount of time that it took for the oxyacetylene torch to cut completely through the different materials. All of the specimens were 1/8" in diameter except the Carbon-3 (C-3) and Carbon-4 (C-4) designs, which were 0.2" in diameter, and the Carbon-6 (C-6) design that was 0.26" in diameter. Thiokol is evaluating the C-6 design for the nozzle-to-case joint and for Joint 2. The first specimen that was tested was a 1/8" diameter stainless steel rod to get a reference point on how hot the flame was. This rod was cut through in only 5 seconds, and the metal was actually melted where the flame cut through. Next, a 1/8" diameter Viton O-ring, the same material used for the O-rings in the rocket nozzle, was tested. It was cut through in about 7 seconds. An all-ceramic seal design was tested next, and it only lasted 6 seconds in the flame. At this point, we realized that we needed to evaluate other material systems, so we designed arrangements braided out of carbon fibers. The three 1/8" diameter carbon fiber designs all lasted about 2 minutes in the oxyacetylene flame. As a point of comparison again, the Shuttle solid rocket motor burn time of 2 minutes 4 seconds is indicated in the figure. Moving up in diameter, the C-3 and C-4 designs with diameters of 0.2" and the C-6 design at 0.26" lasted about six and a half minutes in the flame. Thus, these thermal barriers can endure 5500°F gases for over three times longer than the solid rockets are actually in operation. After the carbon thermal barriers were removed from the flame, the areas where the flame cut through them were just as soft and flexible as before they were tested. There were no signs of melting, charring, or embrittlement. We believe that the carbon fibers were actually being oxidized as they were cut through. Carbon fibers oxidize at temperatures above 600 to 900°F depending on the type of fiber. At the other end of the spectrum, the sublimation temperature of carbon is 6900°F. Therefore, the temperature of the rocket and the oxyacetylene torch at 5500°F is hot enough for oxidation of the fibers but not hot enough for sublimation to occur. Also, these tests are probably conservative in terms of burn resistance because they were performed in an oxidizing ambient atmosphere. The rocket exhaust chemistry is not as oxidative, though. It is possible that the carbon thermal barriers could be exposed to rocket exhaust in the Shuttle solid rocket motors and not even be effected.

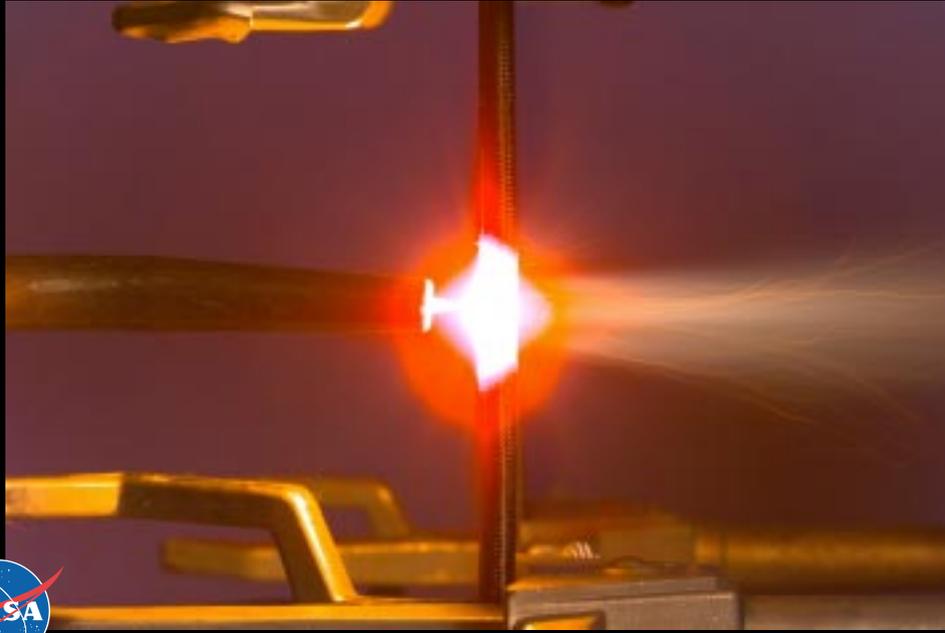
## Candidate Thermal Barrier for Shuttle SRM 5500°F Oxyacetylene Flame on Thermal Barrier

This chart shows the thermal barrier while it is being exposed to the oxyacetylene torch. An incandescent fireball can be seen around the thermal barrier, which is positioned at the tip of the inner cone of the flame. In actuality, this fireball is too bright to look at with the naked eye, and welding glasses must be used to view the test. However, this image was taken with a digital camera that filtered out the brightness of the flame.

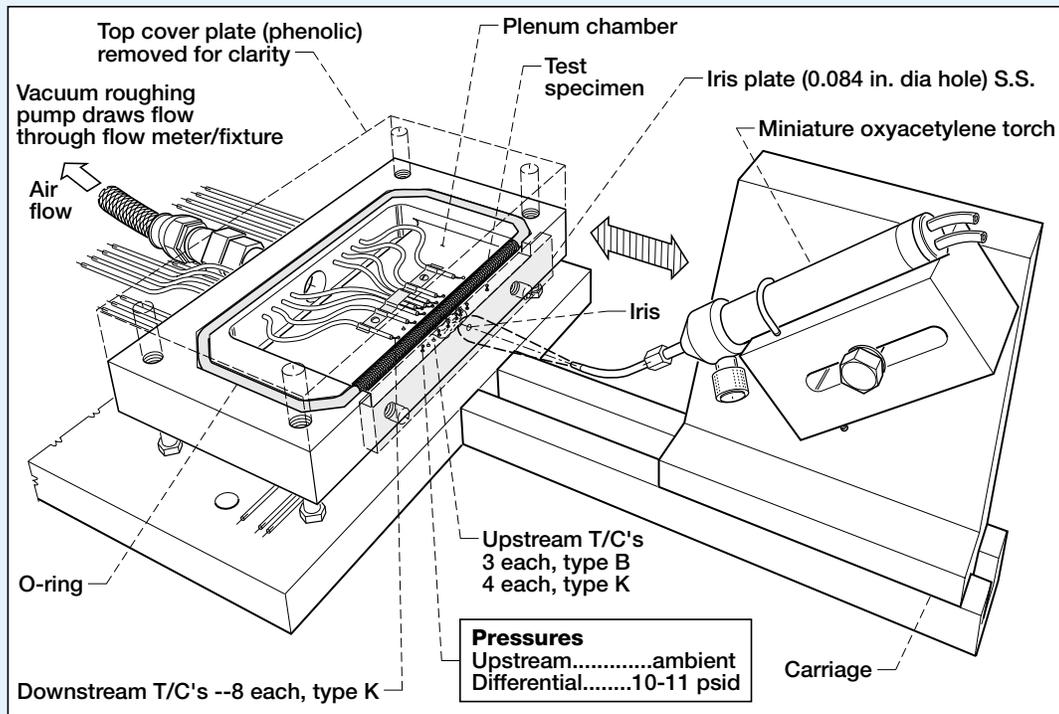
## Temperature Drop Test Fixture

Although the burn tests showed that the carbon thermal barrier designs could resist extreme temperatures for extended periods of time, a test method was required that would more accurately simulate the conditions that the thermal barrier would be subjected to in a rocket. Therefore, we designed a new fixture to measure the temperature drop across and along the thermal barrier in a compressed state when subjected to narrow jets of hot gas at upstream temperatures of 3000°F. The thermal barrier was compressed between two plates of phenolic material to simulate the insulation of the solid rocket motors. Specimens were instrumented with thermocouples on both their upstream and downstream sides to measure the temperature drop across and along the specimen when it was exposed to a hot gas jet from a miniature oxyacetylene torch. An “iris plate” was secured between the torch and the specimen, and a hole in this plate focussed the flame of the torch into a narrow 0.08-inch diameter jet. A vacuum roughing pump hooked up to the plenum chamber downstream of the specimen ensured that hot gas flow from the torch was drawn through the specimen. A flow meter downstream of the fixture measured the amount of flow that passed through the specimen during a test. Pressure transducers measured the upstream pressure (ambient) and differential pressure (10-11 psid) across the specimen. Tests were typically conducted for about a thirty-second torch application.

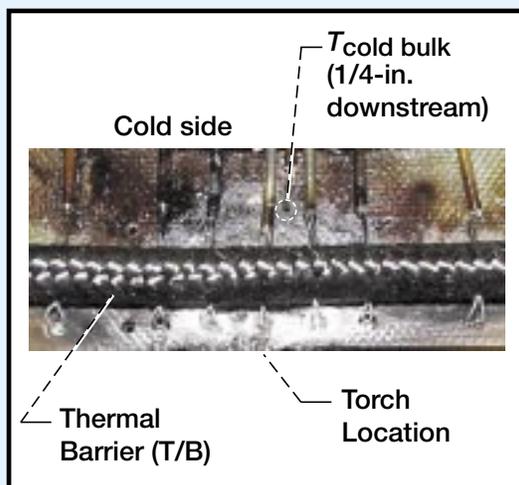
Close-Up Showing Thermal Barrier and Instrumentation

This chart shows two photographs of the temperature drop test fixture. The photo on the left shows a specimen as it is instrumented with thermocouples. A pair of thermocouples was aligned directly in the center of the hot gas jet on the upstream and downstream sides of the specimen. Additional thermocouples were placed 1/4", 1/2", and 1" away from the center thermocouples on both sides of the specimen. The tips of the thermocouples were tucked into the outermost sheath layer to measure the surface temperature of the specimen during a test. An additional thermocouple was located 1/4" downstream of the specimen in line with the center thermocouples to measure the temperature drop one specimen diameter downstream. This was referred to as the "cold bulk" temperature.

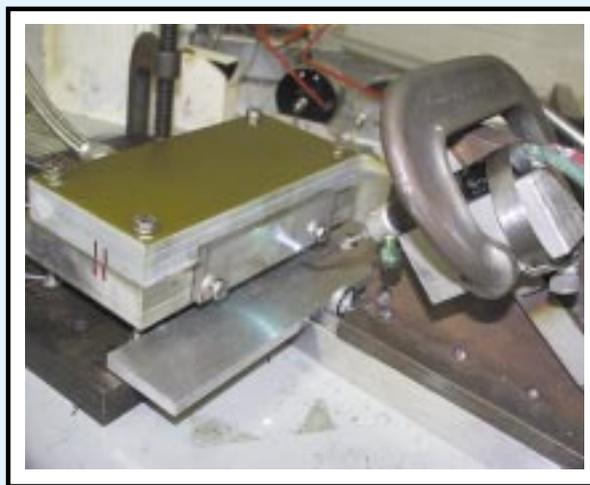
Test in Progress

The photo on the right shows the fixture as the torch is being moved toward the iris plate.

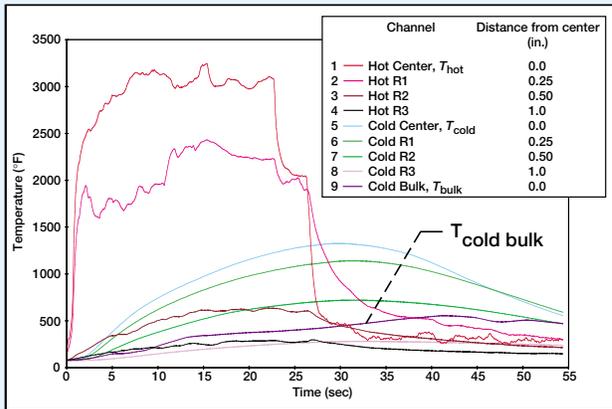
Temperature vs. Time  
Hot/Cold Sides and  $T_{\text{cold bulk}}$

$T_{\text{cold bulk}}$  = Temperature 1/4-in. downstream, aligned with centerline of jet

This chart shows the results of temperature drop tests performed on the 0.26" diameter C-6 thermal barrier. The plot on the left shows temperature traces recorded for a 20 to 25 second torch exposure. Temperature traces for the center thermocouples and those to the right of center on both the upstream and downstream sides of the thermal barrier are shown in degrees Fahrenheit. Thermocouple readings to the left of center were symmetric to those to the right of center and are not shown here for clarity. One can see that the center thermocouple on the hot side reached about 3200°F and that the temperature readings decreased for the thermocouples farther from center. The center thermocouple on the cold side reached about 1200°F with temperatures dropping away from center. Even after a 20 to 25 second torch exposure, the temperature 1/4" downstream of the thermal barrier barely reached 500°F, well within the Viton O-ring temperature limit.

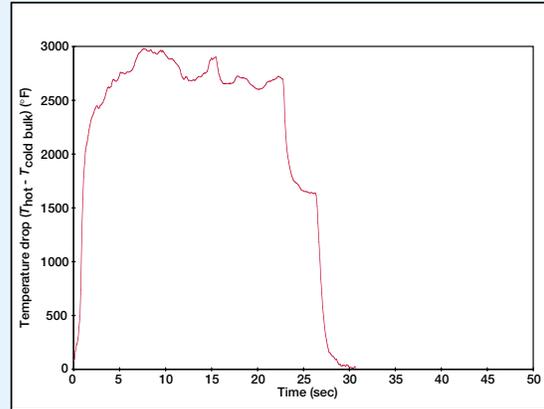
Temperature Drop  
( $T_{\text{hot}} - T_{\text{cold bulk}}$ ) vs. Time

The plot on the right shows the temperature difference between the center thermocouple on the hot side and the cold bulk temperature. A large temperature drop of 2500 to 2900°F was observed during this test.

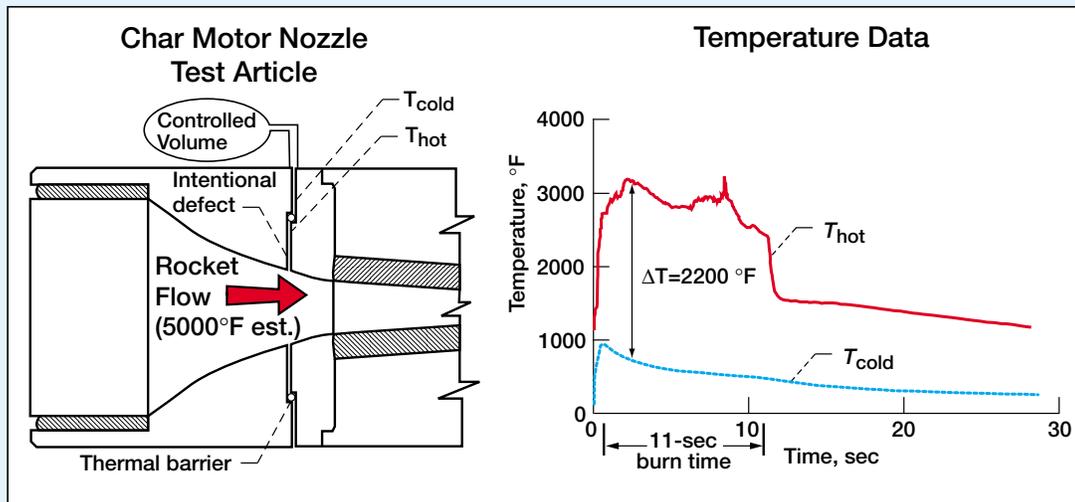
## Thiokol Char Motor Test Results: C-6 Thermal Barrier

- Char motor test with intentional large joint defect (0.060") subjects thermal barrier to hot rocket gas for temperature and material performance evaluation
- Thermal barrier performed extremely well subjected to hot gas (3200 °F) for 11 sec firing – simulating maximum downstream cavity fill time
- Thermal barrier reduced incoming gas temperature 2200 °F, spread the incoming jet-flow, and blocked hot slag thereby offering protection to O-rings

Thiokol has performed a series of tests in a subscale rocket "char motor" in which the thermal barrier was exposed to hot rocket gases. The figure on the left shows the test setup in which hot gases passed through an intentional 0.06" wide joint defect and impinged on the thermal barrier before filling a controlled downstream volume. Pressures and temperatures were measured both upstream and downstream of the thermal barrier. The plot on the right shows temperature traces from a test performed on a 0.26" diameter C-6 thermal barrier specimen in the char motor. The thermal barrier performed extremely well while withstanding hot side temperatures of 3200°F for an eleven-second rocket firing. It dropped the temperature by 2200°F across its diameter, spread the incoming hot gas flow, and blocked hot slag. When the specimen was removed from the char motor, it was in excellent condition with no apparent burning or charring. These test results were consistent with the results from our temperature drop tests in which we measured 2500+°F drops across the same C-6 thermal barrier design.

- Thermal barrier performed extremely well subjected to hot gas (3200 °F) for 11 sec firing—simulating maximum downstream joint cavity fill time
- Thermal barrier reduced incoming gas temperature 2200 °F, spread incoming jet-flow, and blocked hot slag thereby offering protection to O-rings.

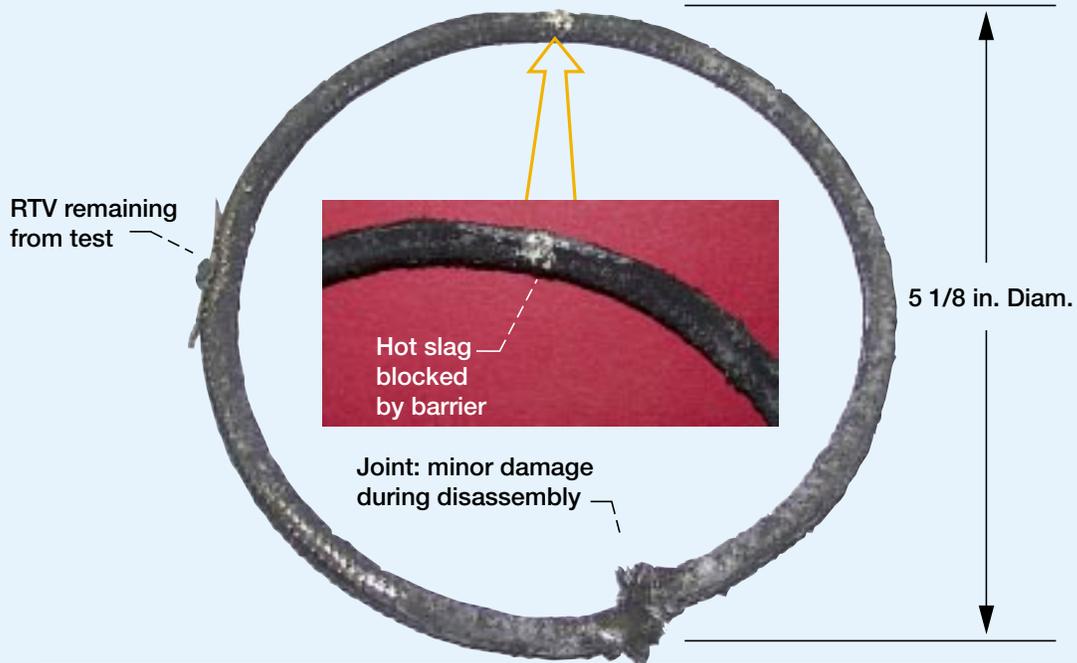
## Thiokol Char Motor Thermal Barrier (C-6) After Test

**Char motor tests demonstrate thermal barrier effectiveness: blocks 3200 °F gas for 11 sec joint fill time, blocks hot slag, and shows minimal damage**

This is a photograph of the specimen that Thiokol tested in the char motor in the previous chart. The specimen was in very good condition with only minor damage at the splice joint caused during disassembly. There were no signs of burning or charring of the specimen, but deposits could clearly be seen both on and between the carbon fibers.

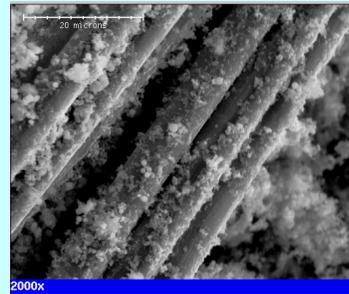
SEM Photo of Upstream Side of Thermal Barrier (2000X)

To further examine the thermal barrier specimen that was tested in the Thiokol char motor, we sectioned the specimen and examined it in a scanning electron microscope. The image at the upper right shows that there was no damage to individual carbon fibers within the specimen. The fibers were still cylindrical and relatively smooth. The thermal barrier did act as an effective slag barrier, though, filtering out particles and trapping them on and between the carbon fibers. To analyze the deposits even further, a chemical analysis was performed on them. At the bottom left of this chart is a chemical analysis of an as-received specimen that had not been tested in the char motor. As would be expected, the only peak that showed up was for carbon, since there were very few other deposits or impurities in the specimen. At the lower right is the plot of the chemical analysis performed on the specimen that was tested in the char motor. This test revealed the presence of aluminum, silicon, chlorine, and potassium in addition to carbon. Through discussions with Thiokol, the presence of all of these species was explained. The aluminum came from the solid fuel used in the rocket. The silicon most likely was deposited on the specimen as the chopped silica phenolic insulation blocks around the specimen became charred. The chlorine came from the ammonium perchlorate oxidizer, and the potassium came from the igniter used to fire the rocket.

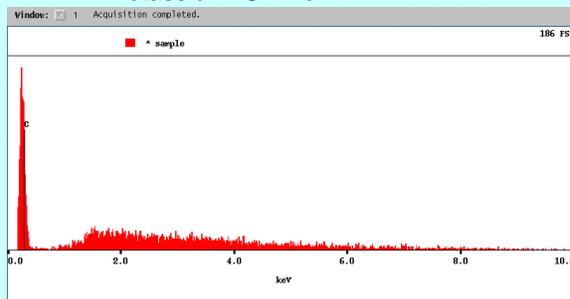
Chemical Analysis of As-Received Thermal Barrier

- Chemical analysis of as-received thermal barrier showed only carbon present
- Chemical analysis of char motor specimen revealed presence of: aluminum, silicon, chlorine, potassium, and carbon
- Potential sources: Aluminum: Rocket fuel;  
Silicon: Chopped silica phenolic insulation blocks;  
Chlorine: Ammonium perchlorate oxidizer;  
Potassium: Unknown

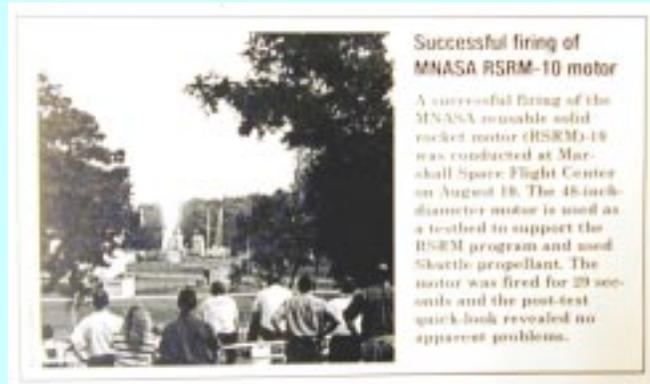
## NASA GRC Thermal Barrier Feasibility Proven in MNASA-10 RSRM

- Carbon-6 thermal barrier tested in MNASA-10 1/5<sup>th</sup>-scale version of full-scale reusable solid rocket motor (RSRM) used to launch space shuttle
- Specimen tested in redesigned nozzle-to-case joint with intentional flaw in nozzle insulation
- Rocket motor fired for 29 seconds

- Hot combustion gases reached thermal barrier: Soot observed upstream of thermal barrier
- No soot downstream
- No damage or erosion to thermal barrier or downstream O-rings

On August 10, 1999, the Carbon-6 thermal barrier was tested in an MNASA-10 1/5<sup>th</sup>-scale version of the full-scale solid rocket motors used to launch the Space Shuttle. Tested in a redesigned nozzle-to-case joint for a 29 second rocket firing, an intentional flaw in the nozzle insulation allowed hot combustion gases to reach the thermal barrier as evidenced by soot observed on hardware upstream of the thermal barrier. Post-test inspection revealed no soot downstream of the thermal barrier and no damage or erosion to either the thermal barrier or to downstream O-rings that the thermal barrier is designed to protect. The results of this test demonstrated that the thermal barrier is capable of protecting downstream O-rings from hot rocket gases in large-scale solid rocket motors.
